**Walton Fire Station**  
Development Feasibility Assessment

November 28, 2023

## **1.0 Executive Summary**

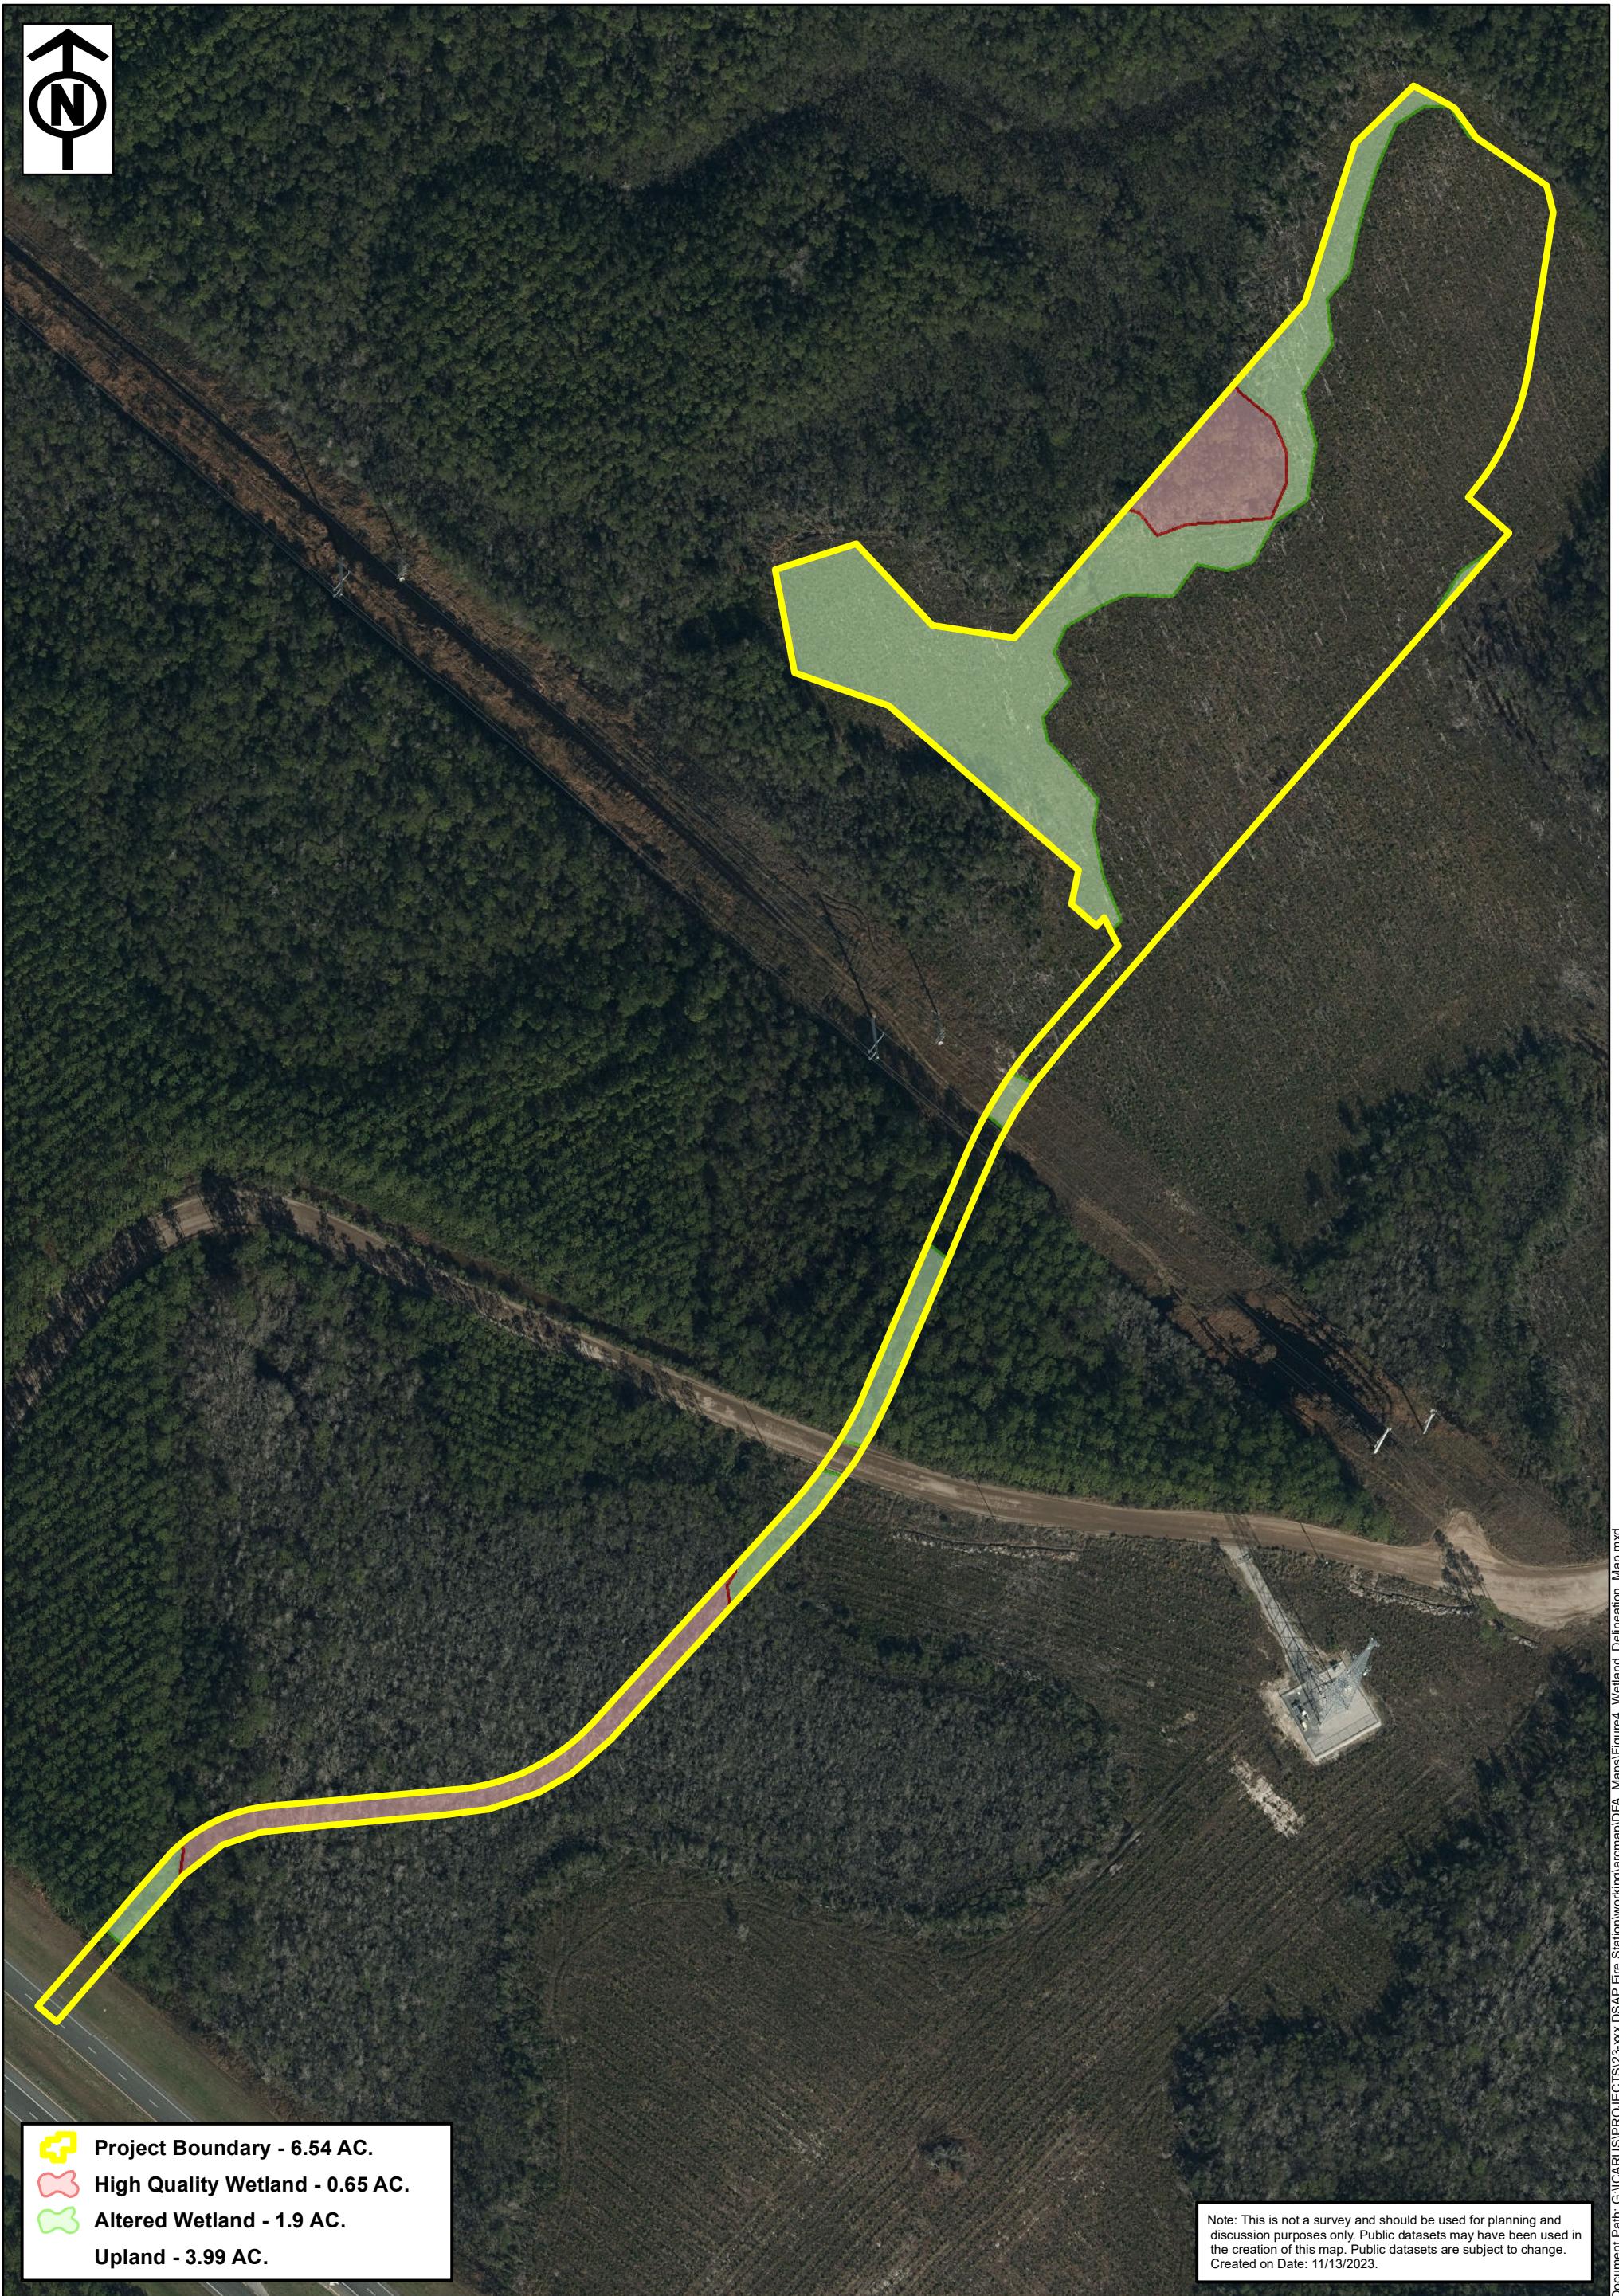
### Figure 4 - Wetland Delineation Map

Jurisdictional wetlands were delineated onsite per the State of Florida methodology prescribed in Chapter 62-340, F.A.C. – See attached Wetland Delineation map (**Figure 4**), FEMA Floodzone map (**Figure 5**) and Topographic map (**Figure 6**). It was found that 1.9 +/- acres of altered wetland, 0.65 +/- acres of high quality wetlands, and 3.99 +/- acres of upland occur on this site per the United States Army Corps of Engineers (USACE) Regional General Permit SAJ – 86 and the Florida Department of Environmental Protection (FDEP) Ecosystem Management Agreement 1 definitions.

-   Project Boundary - 6.54 AC.
-   High Quality Wetland - 0.65 AC.
-   Altered Wetland - 1.9 AC.
- Upland - 3.99 AC.
